TECHNICAL REPORT NO. 11738

INFRARED NON-DESTRUCTIVE
ANALYSIS OF SOLID RUBBER
ROAD WHEELS

FEBRUARY 1973

U.S. ARMY TANK AUTOMOTIVE COMMAND Warren, Michigan

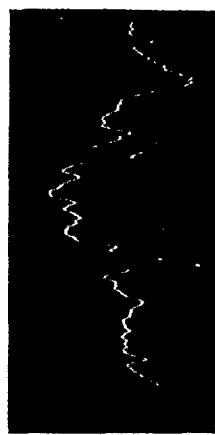
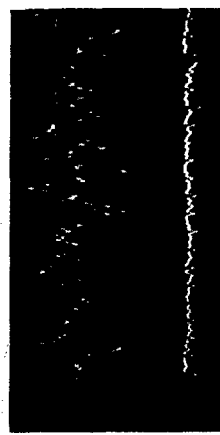
Figure 12 - Stripped Rubber Tread Interface

Feathering of Adhesive Along Wear Flange (2)

Description of Defects:
 Unbond Along Length of Wear Flange
 (1) Unbond
 (2) Unbond

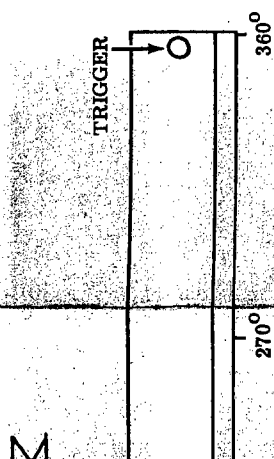
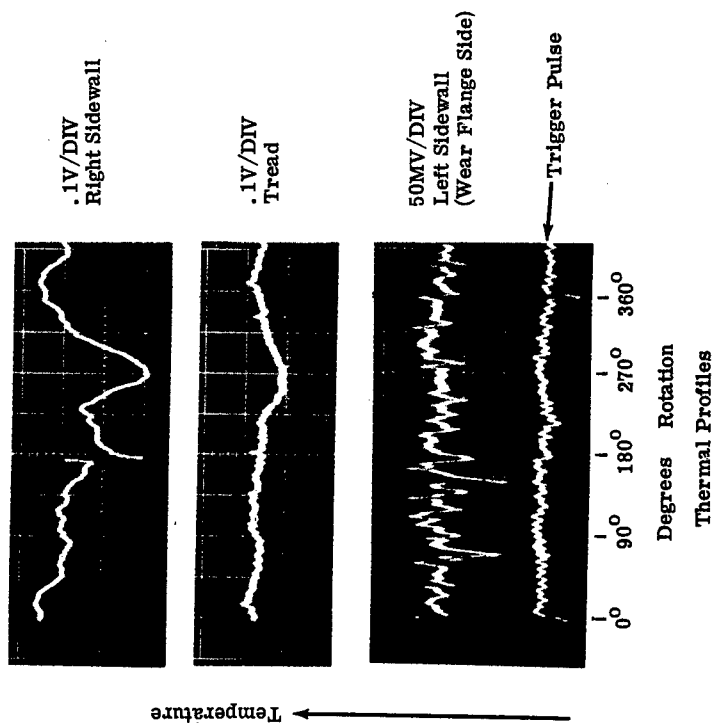
Figure 15 - Stripped Rubber Tread Interface

Description of Defects: All Defects Less Than 1 Sq. In.

Track Guide Damage

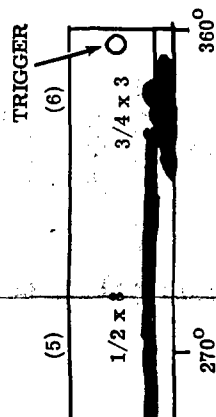
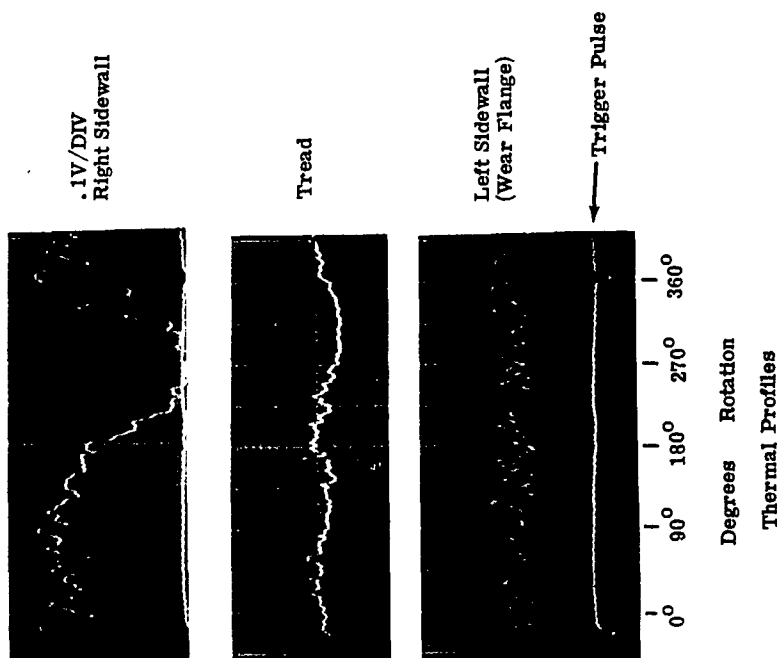
Figure 17 - Stripped Rubber Tread Interface

Track Guide Damage, Defect
No. 2 and 3
